SARL JEAN BUSER
DISTRIBUTOR FOR PORSCHE MECHANICAL PARTS AND ACCESSORIES

**INSTALLATION INSTRUCTIONS AND TROUBLE-SHOOTING PROCEDURES
FOR THE MODEL 356 + 912 PERMA-TUNE ELECTRONIC IGNITION BOX**

356.090220

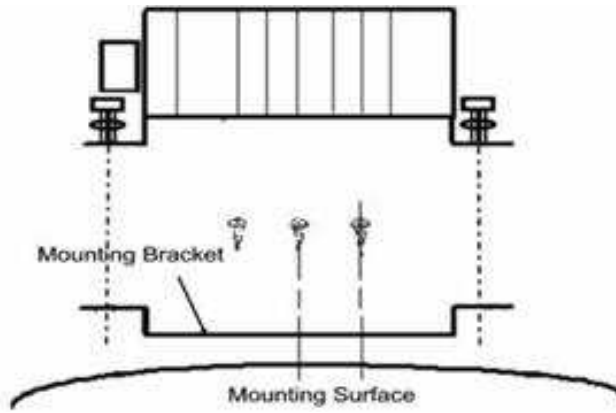
MOUNTING :

Bolt the 356 + 912 ignition box to a flat surface so as not to bend the mounting flanges. The flanges can be cut or drilled. Avoid mounting it near the exhaust system. If a flat mounting surface is not available, mount an adapter bracket in the desired location and bolt the box to the bracket. When mounting the box on a non conductive surface the mounting flanges need not be grounded.

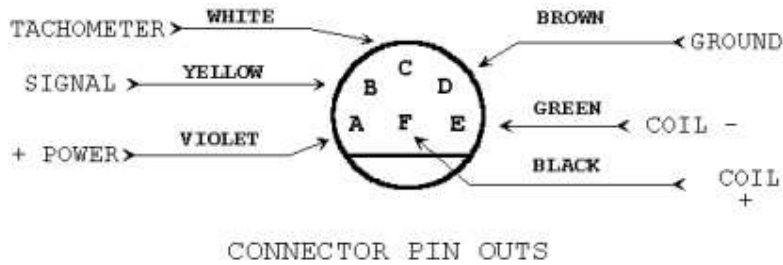
CONNECTIONS :

Solder and heat shrink tubing connections are recommended. Crimp connectors of the marine variety are acceptable. Any wires not used must be insulated. Cut wires as short as possible, do not coil excess wire.

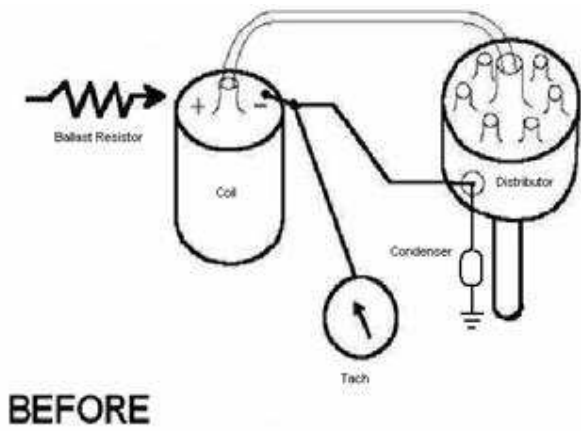
IGNITION SYSTEM DIAGRAM BEFORE THE PERMA-TUNE 356 + 912 INSTALLATION

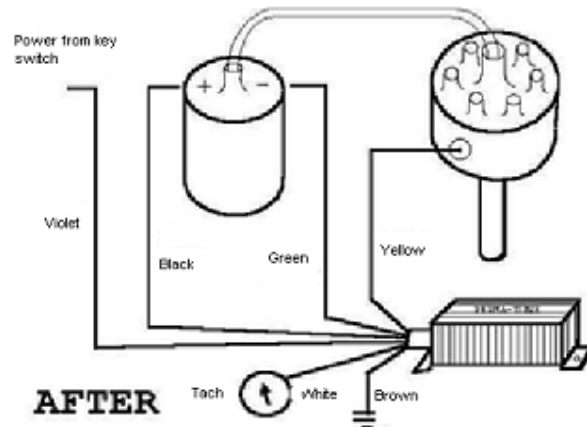
IGNITION SYSTEM DIAGRAM AFTER THE PERMA-TUNE 356 + 912 INSTALLATION

A. Violet Wire. Ignition switch power. DO NOT CONNECT DIRECTLY TO BATTERY. Eliminate the ballast resistor if so equipped. Power requirements are 5 Amps continuous. Use 30 Amp fuse protection, use 12 Gauge wire to extend the Violet wire if required.

B. Yellow Wire. Trigger signal to breaker points. Also will operate most tachometers on Porsche 911 '72-'77 and 914 1.8L. Rev limiting tachometers can be connected here. Disconnect the condenser if so equipped. If you are installing the Model 911030 Breakerless Pickup, connect the black wire of the pickup to the yellow wire. If your car is equipped with an RPM switch, connect it to the yellow wire.

C. White Wire. Optional tachometer signal for Porsche 914 2.0 L, 912, 356 and most other automotive tachometers. Tape off to insulate properly if not used.

D. Brown Wire. Ground. Connect to engine ground. Note: Be certain that the engine and chassis ground cables and the battery minus terminal cables are securely connected. A bad ground connection between the engine and chassis could cause the brown fusible link at pin D to burn out.
