INSTALLATION INSTRUCTIONS AND TROUBLE-SHOOTING PROCEDURES FOR THE MODEL 901 PERMA-TUNE ELECTRONIC IGNITION BOX

911.090220

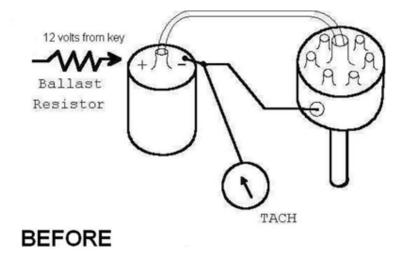
IGNITION SYSTEM DIAGRAM BEFORE THE PERMA-TUNE 901 INSTALLATION :

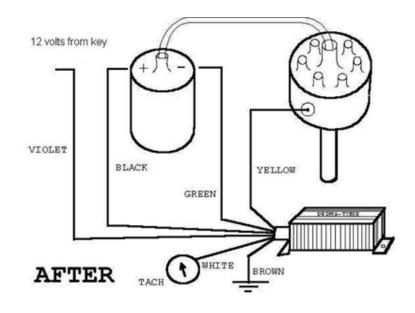
IGNITION SYSTEM DIAGRAM AFTER THE PERMA-TUNE 901 INSTALLATION :

<u>A. Violet Wire.</u> Ignition switch power. **DO NOT CONNECT DIRECTLY TO BATTERY.** Eliminate the ballast resistor if so equipped. Power requirements are 5 Amps continuous and 50 Amps surge at 12 Volts. Use 30 Amp fuse protection, use 12 Gauge wire to extend the Violet wire if required. If you are installing the Model 911030 Breakerless Pickup, connect the red wire of the pickup to the Violet wire and the 12 Volt wire.
