**INSTALLATION INSTRUCTIONS AND TROUBLE-SHOOTING PROCEDURES
FOR THE MODEL 928 PERMA-TUNE ELECTRONIC IGNITION BOX**

928.090220

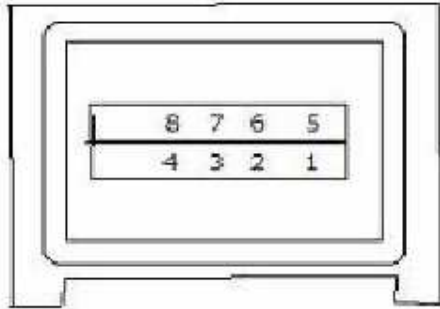
View looking at the ignition box:

The connector pin outs in the diagram that follows are provided for your convenience.

- 8= Power - Red
- 7= Signal {distributor pin A) - green
- 6= Signal {distributor pin B) - brown
- 5= Ground
- 4= Ground
- 3= Ground
- 2= Tachometer- black / purple
- 1= Coil Hot - white

To quickly test the triggering circuit without the use of an oscilloscope: Unplug the harness connector from the ignition box. Refer to the 928 installation instructions' diagram, connect an Ohmmeter between pins 7 and 6 of the harness connector. To prevent the possibility of misdiagnosis, tug on the green triggering signal wire located at the base of the distributor while viewing the meter. The published specification for the magnetic pulse generator is 600 Ohms + /- 100 Ohms. Our experience has shown that a variation of +/ - 25 Ohms indicates degradation of the triggering circuit.

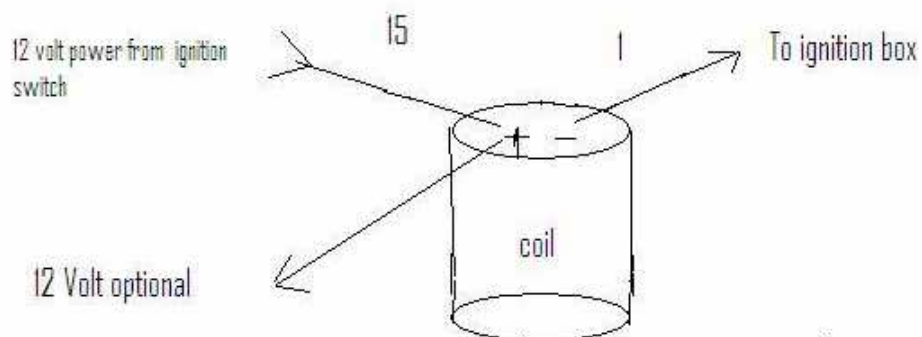
BEFORE PERMA-TUNE INSTALLATION :
